# Manhole Inspection Summary

Manhole # S45C\_\_046MH

Insp Date: **8/15/08 9:00 AM**

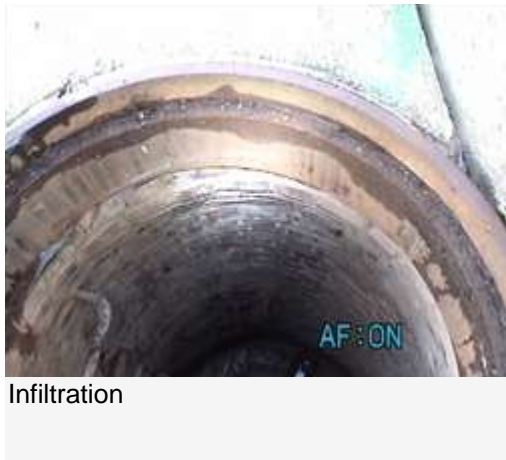
Defect 2

Infiltration: ☐ None ☒ **Joint** ☐ Cracks ☐ Mortar ☐ Roots ☐ Wall

Infiltration: ☐ None ☐ Joint ☐ Cracks ☐ Mortar ☐ Roots ☒ **Wall**

Infiltration

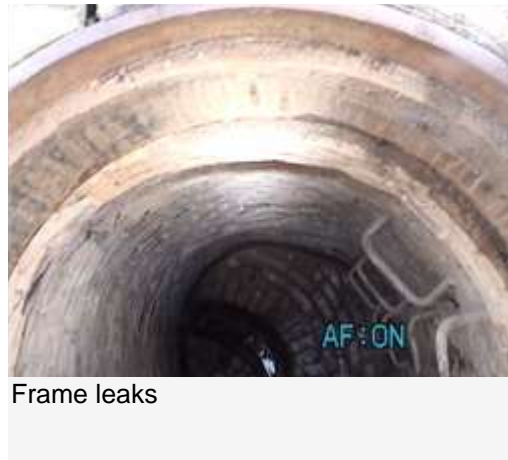
Defect 1

☒ **Leaks**

Frame leaks

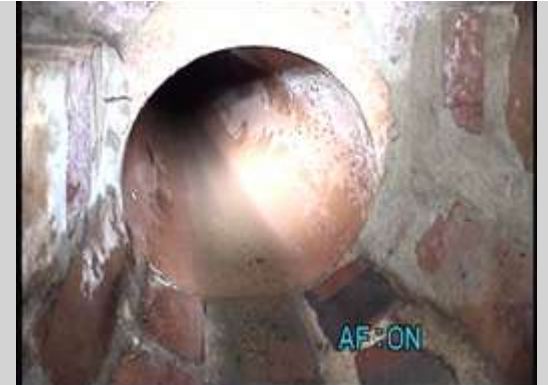
12 O'Clock Outflow

8 in. Circular Gravity Sewer  
Pipe Out @ 12 O'Clock

Infiltration: **None** Pipe Seal Cond: **Sound**

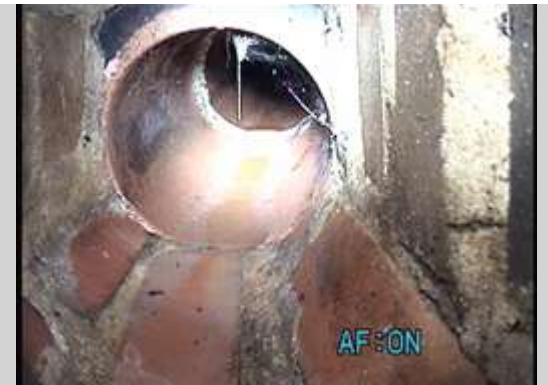
9 O'Clock Inflow

6 in. Circular Gravity Sewer  
Pipe In @ 9 O'Clock

Infiltration: **None** Pipe Seal Cond: **Sound**
